SPECIAL ISSUE

OCTOBER, 1969

NATURAL FEATURES CAUSED BY A CATASTROPHIC STORM IN NELSON AND AMHERST COUNTIES, VIRGINIA

The State Geologist received authorization from the Office of Civil Defense to inspect the flood-damaged area. The photographs appearing in this article were taken by staff members of the Virginia Division of Mineral Resources, Thomas M. Gathright and Donald W. Hutcheson, who accompanied Dr. James L. Calver on the inspection trip, August 28, 1969.

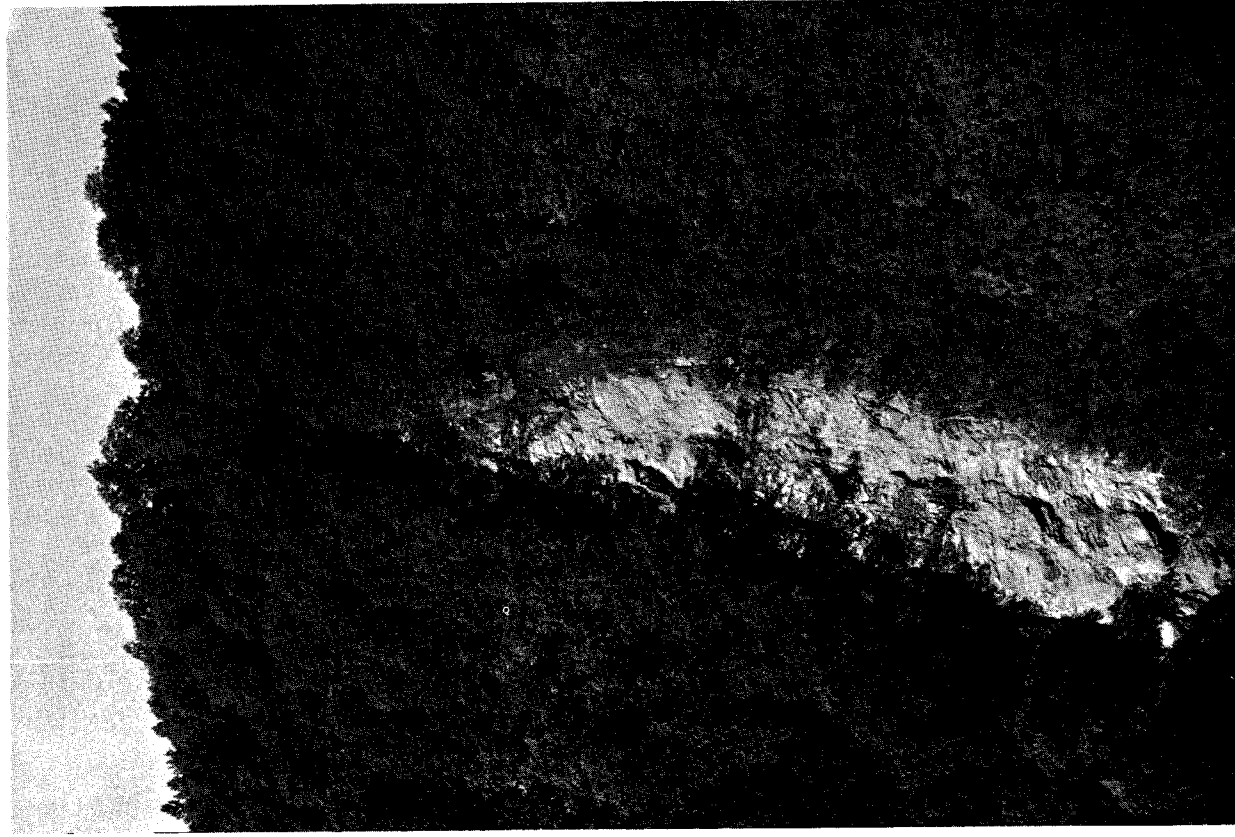
1 Upper portion of typical chute where bedrock of the Lovington gneiss (Precambrian age) has been laid bare. West slope of Pats Knob below Shields Gap, about 5 miles northeast of Roseland.

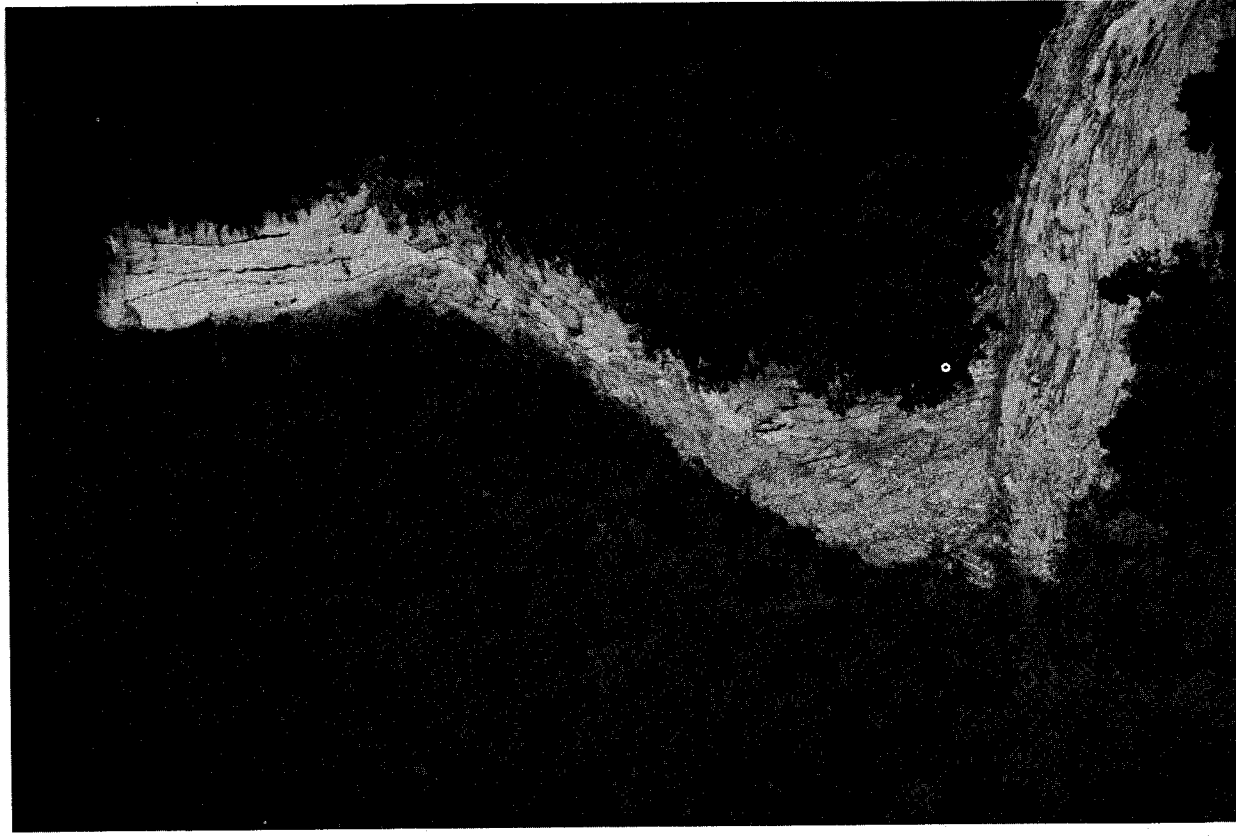
2 Chute with multiple gullies eroded into weathered bedrock of the Erwin sandstone of Cambrian age. On west side of Blue Ridge about 4.5 miles south of Fairfield, Rockbridge County.

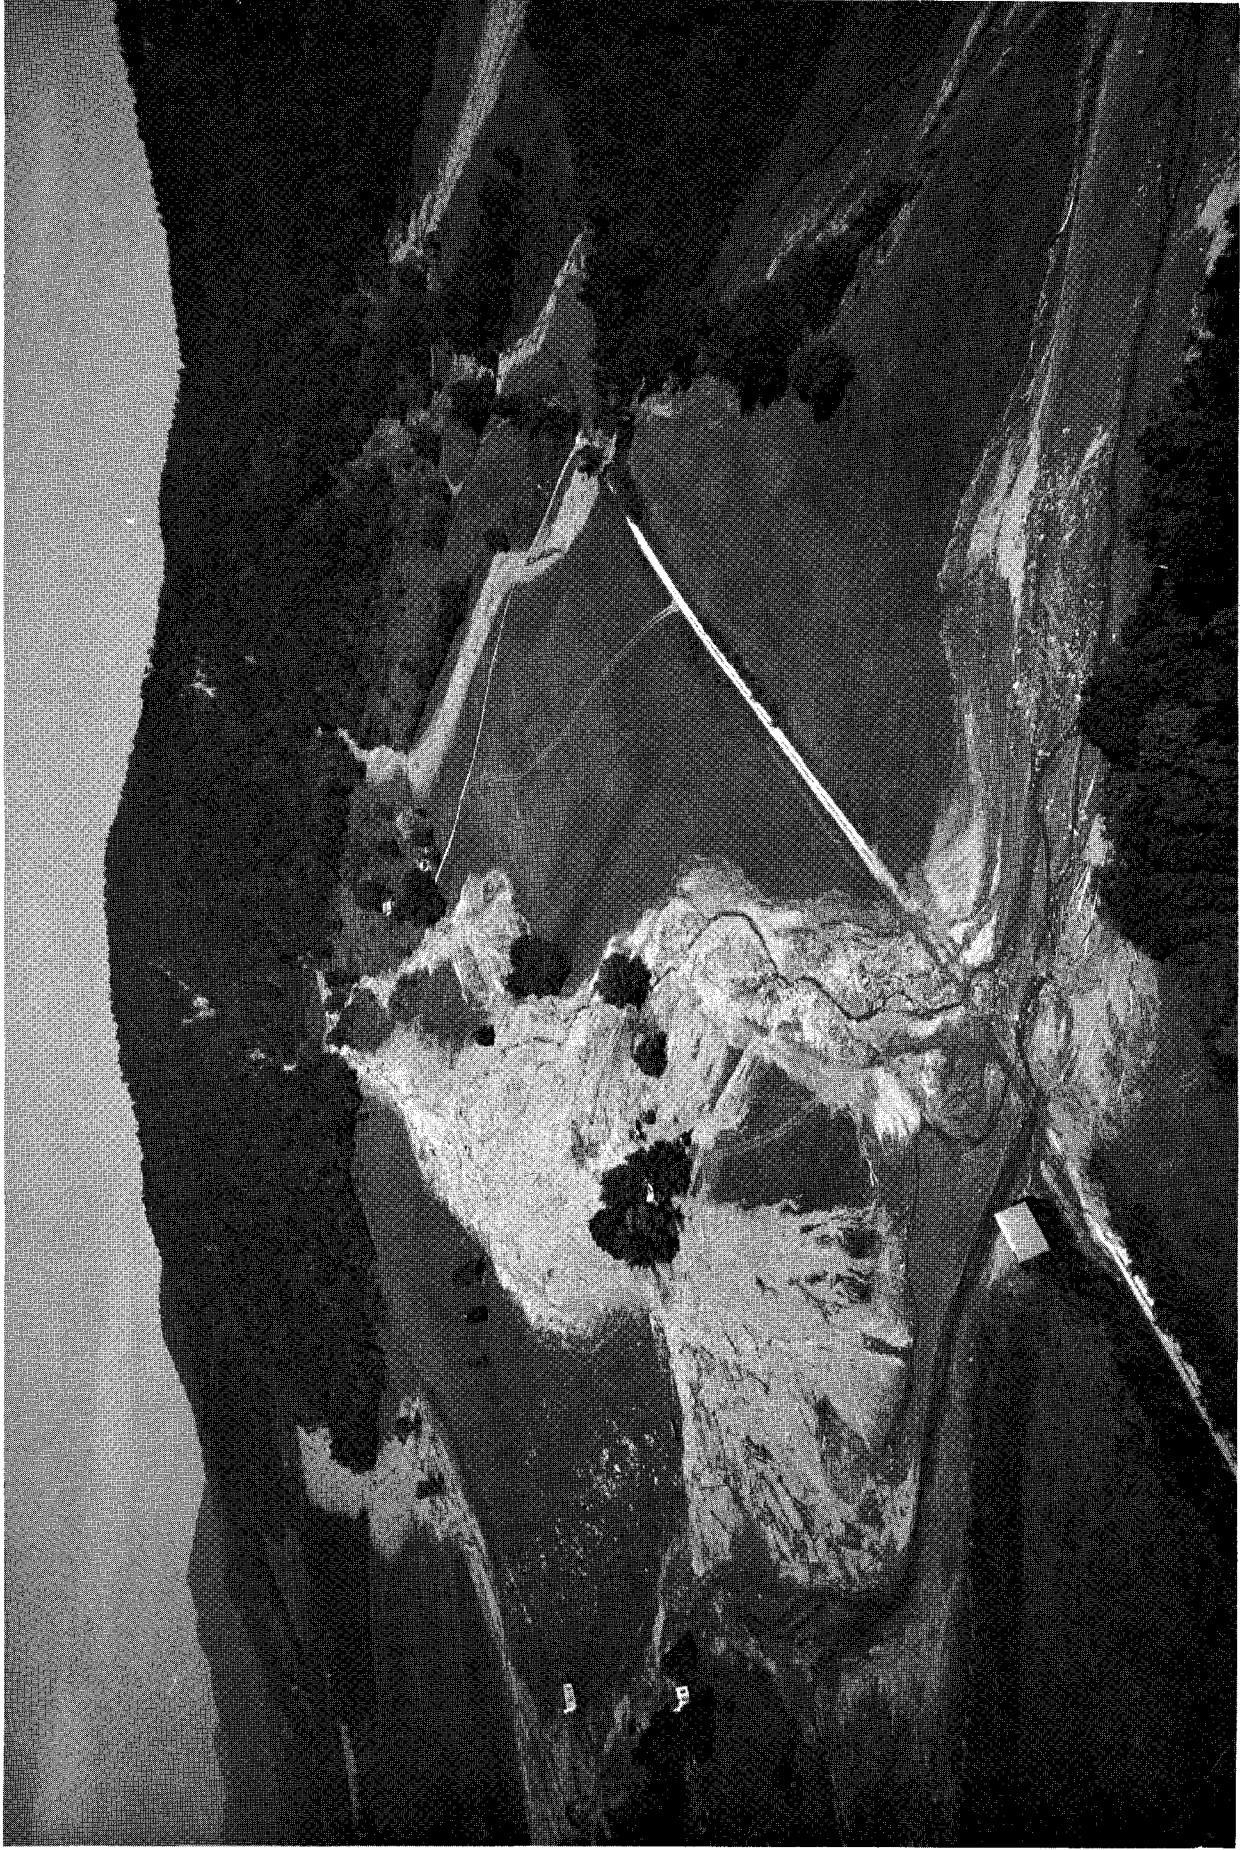
3 Rubble-strewn slopes and partially braided streams in the foothills of Woods Mountain. Shaeffer Hollow, about 2.5 miles northeast of Roseland.

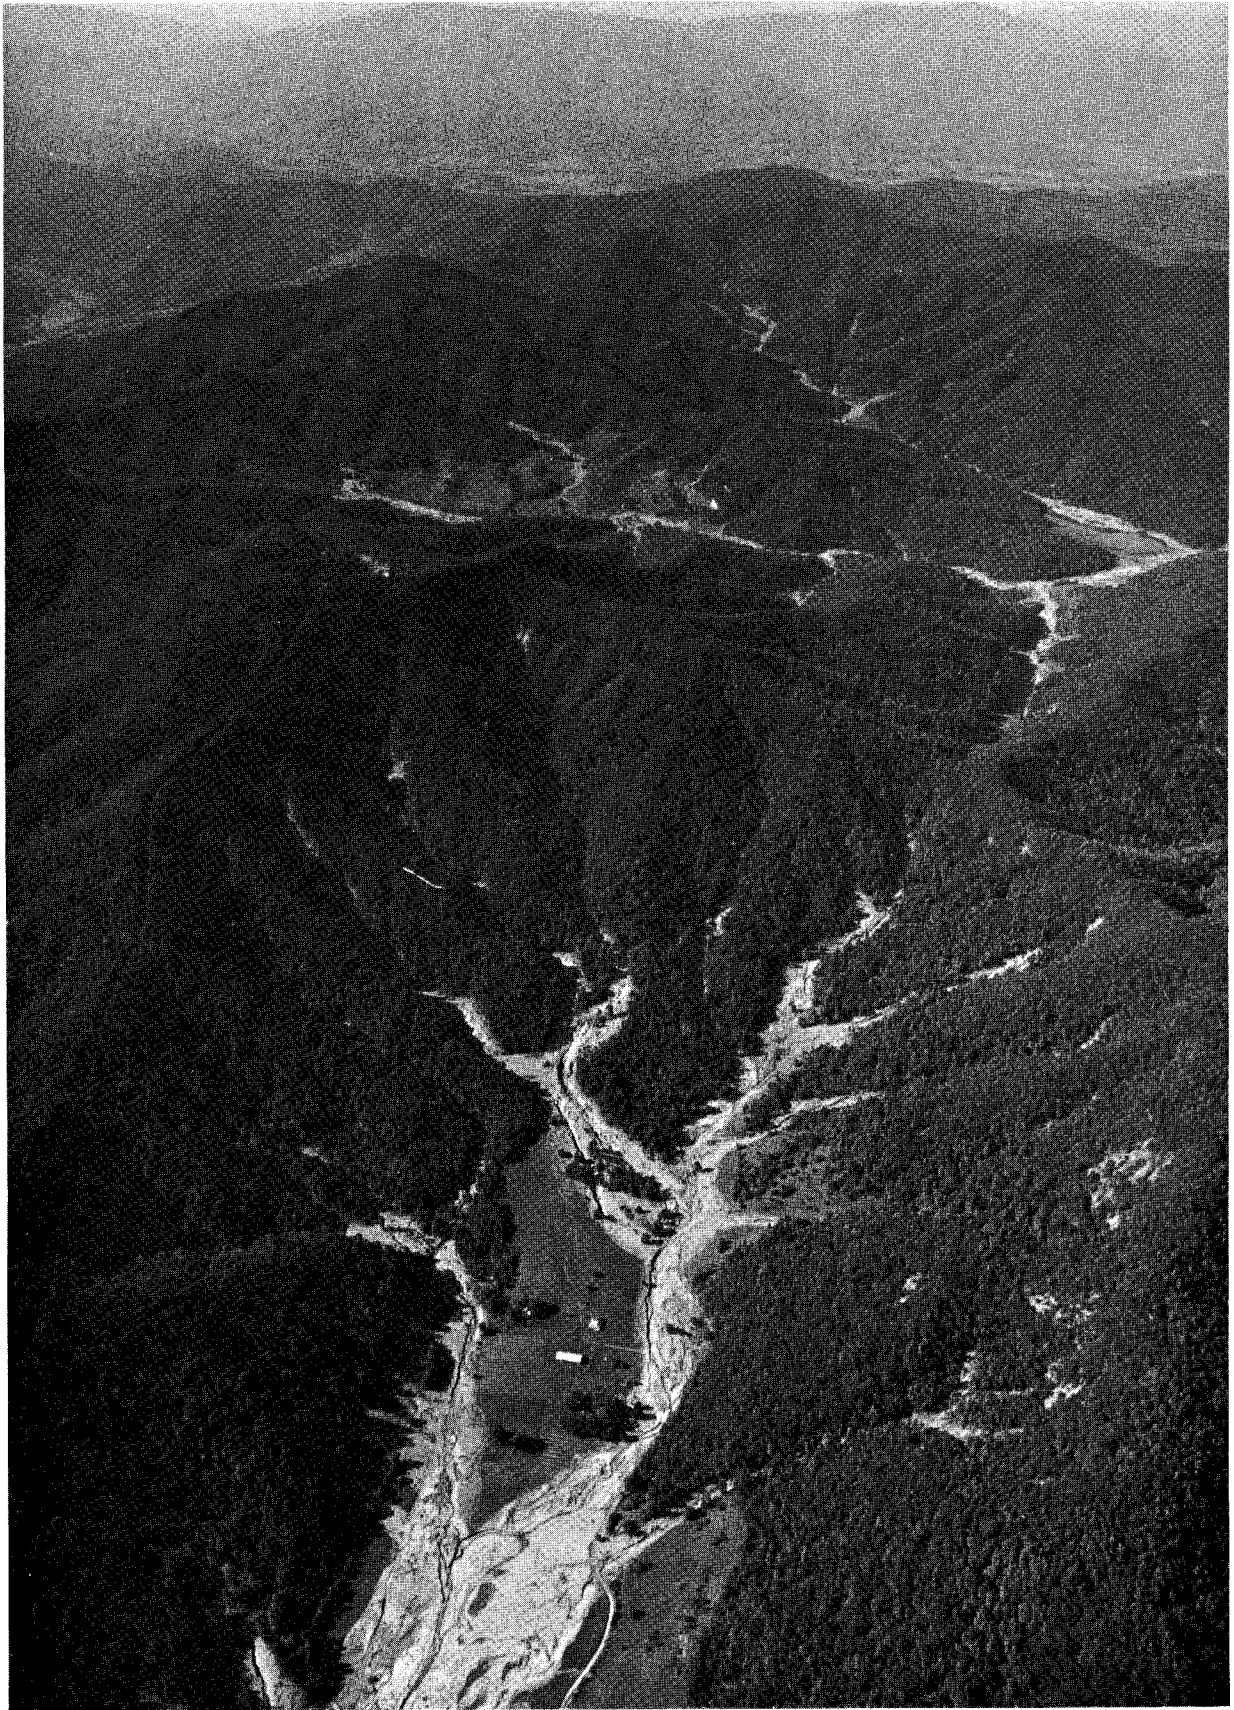
4 Numerous chutes from which debris was disgorged onto valley fills; streams, were subsequently entrenched. Head of Fortunes Cove south of High Top Mountain (left center), about 2 miles northwest of Lovington.

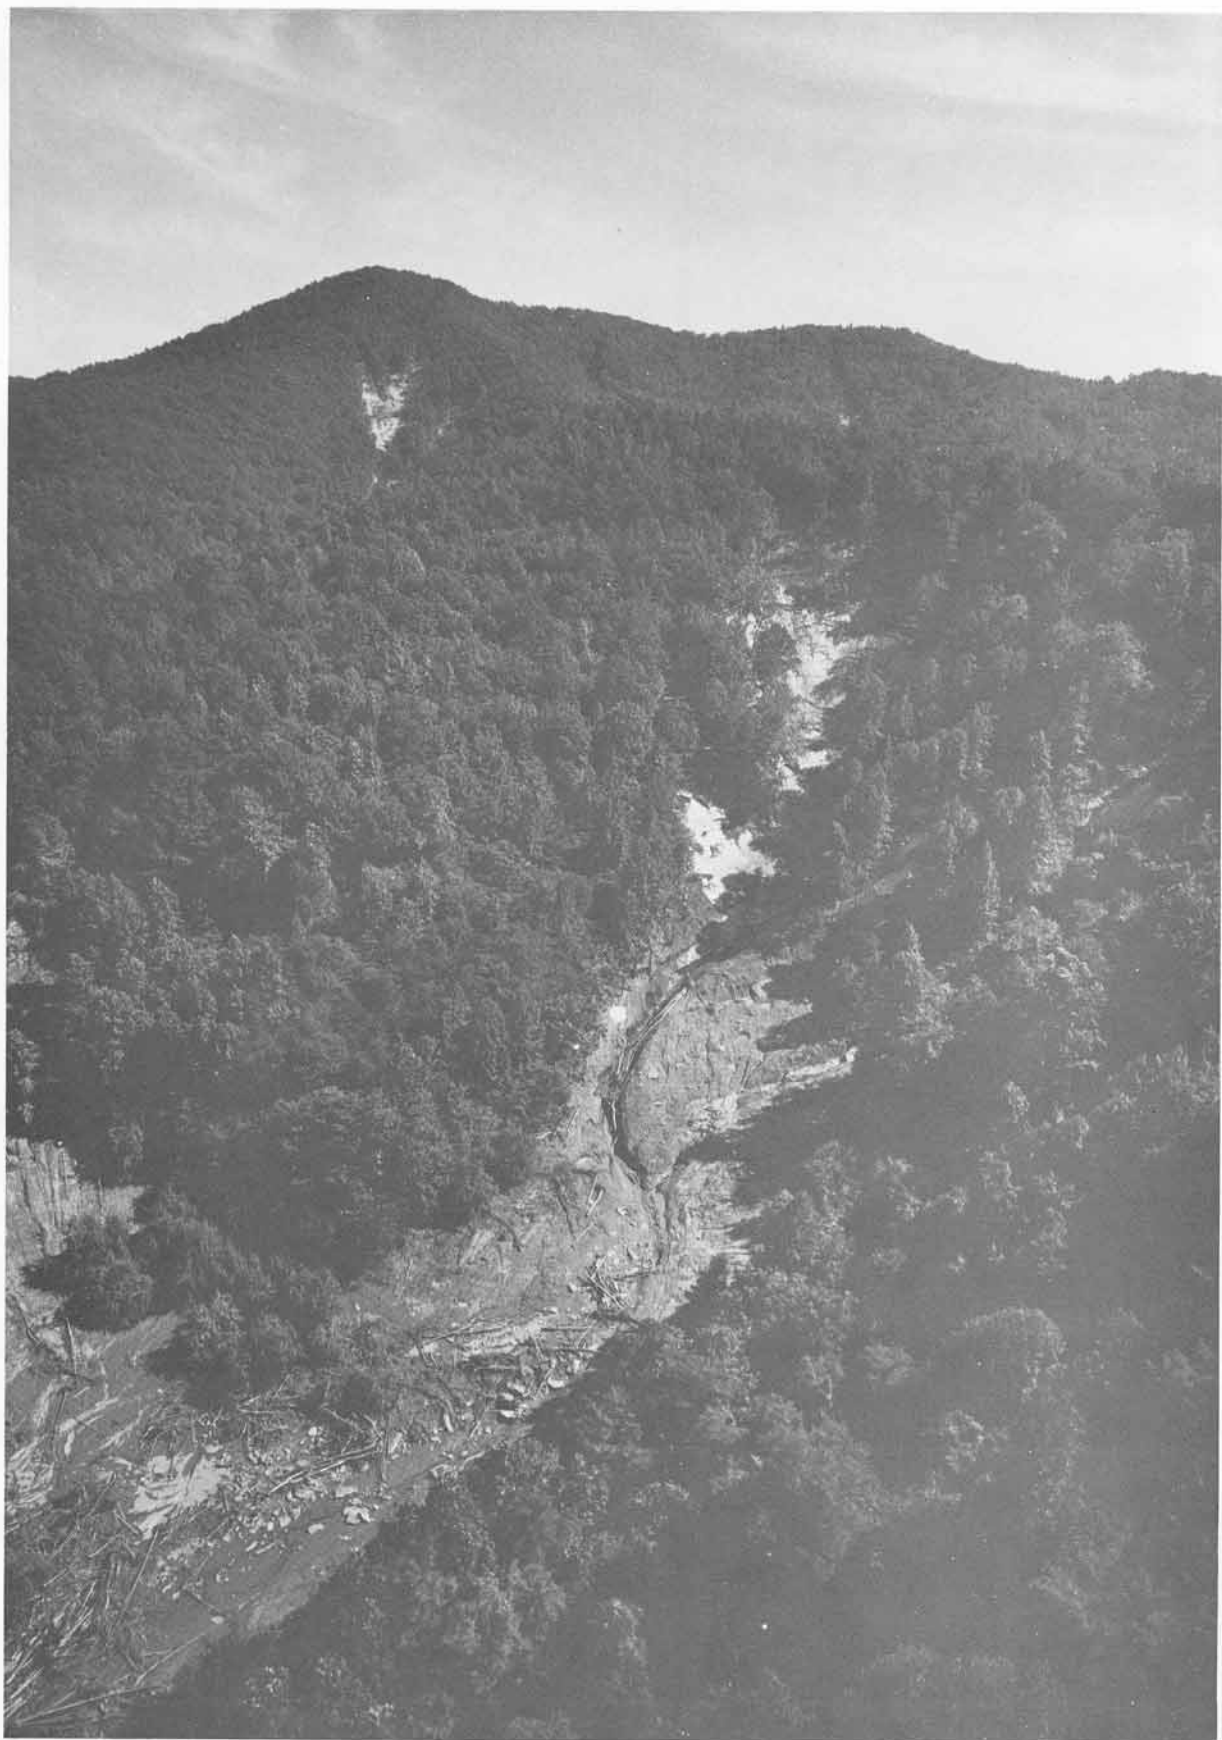
5 Accumulation of coarse boulders, tree trunks, and soil near the base of a steep chute. Just north-east of Pats Knob (background), about 5 miles northeast of Roseland.

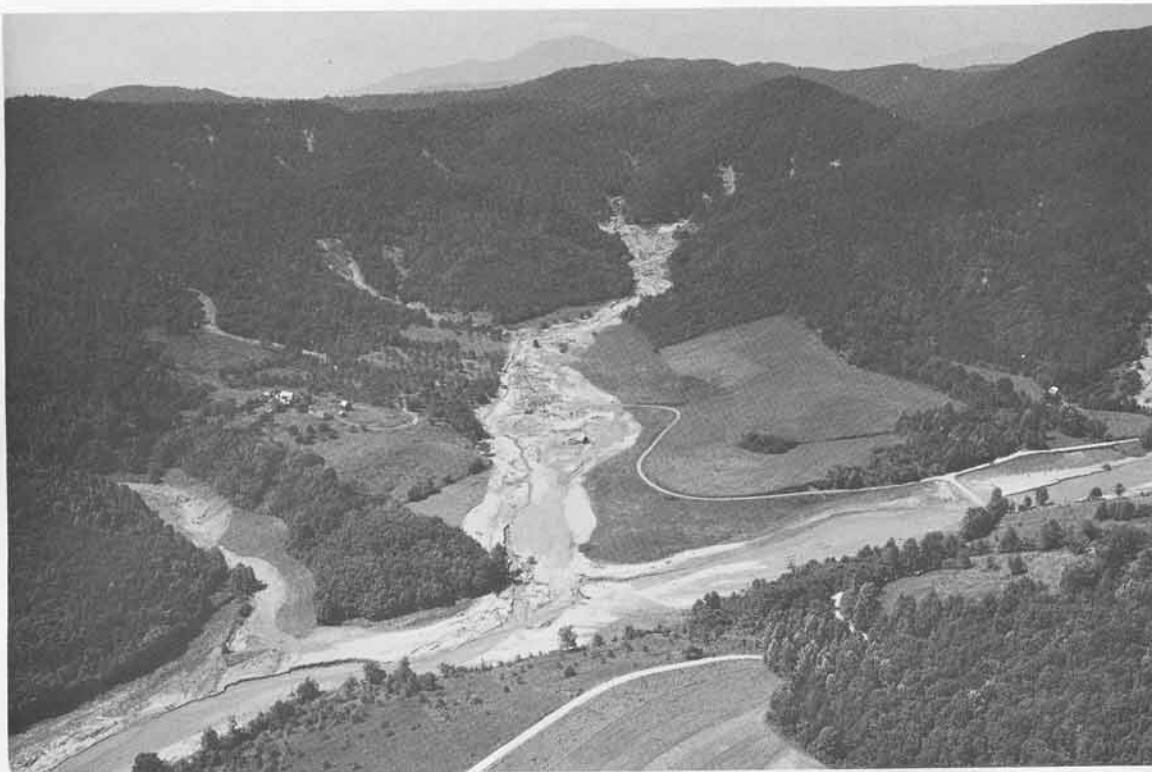
6 Torrentially deposited gravels and tree trunks in valley bottom along toe of pre-existing coluvial fan (left center). Note scarps along banks of streams. Wills Cove (center), just southwest of Fortunes Cove, about 2 miles west-northwest of Lovington.

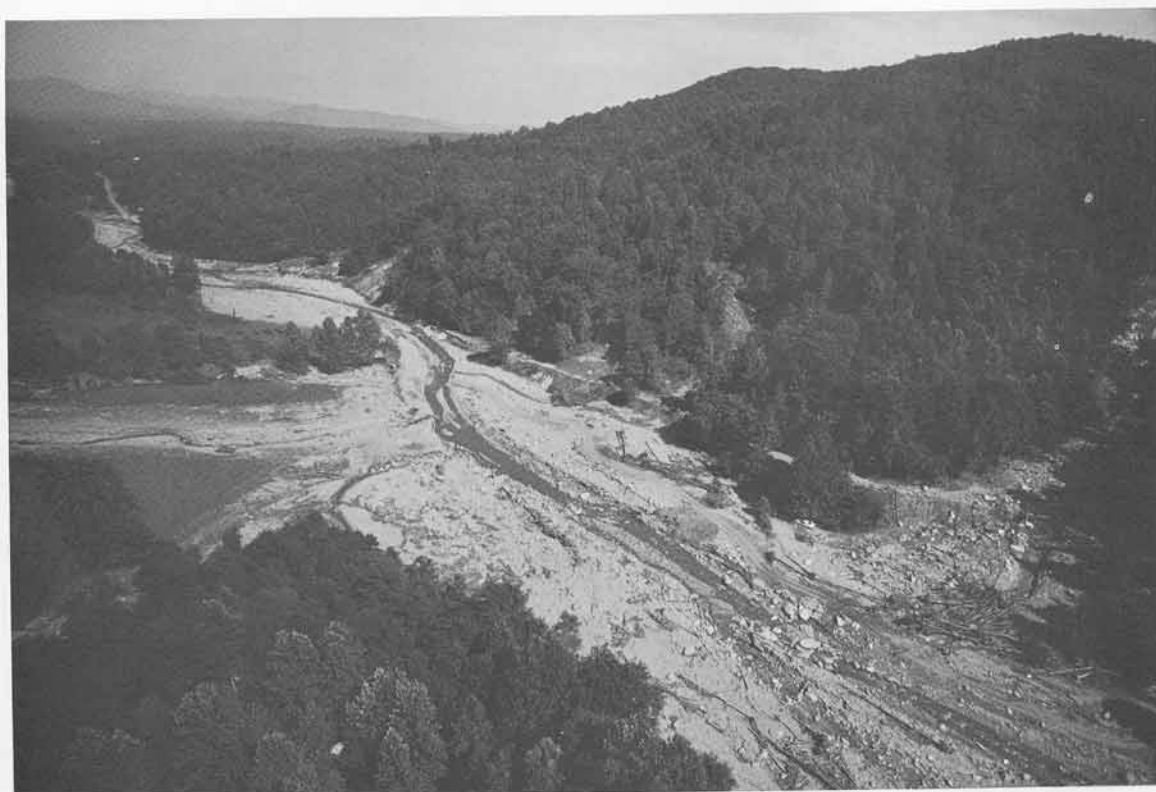
7 Stream meandering through rubble field derived from material contributed by chutes occurring along flanks of valley. Coarse boulders (lower right) were discharged from such a chute. Looking downstream along Davis Creek, about 3.5 miles southwest of Woods Mill.

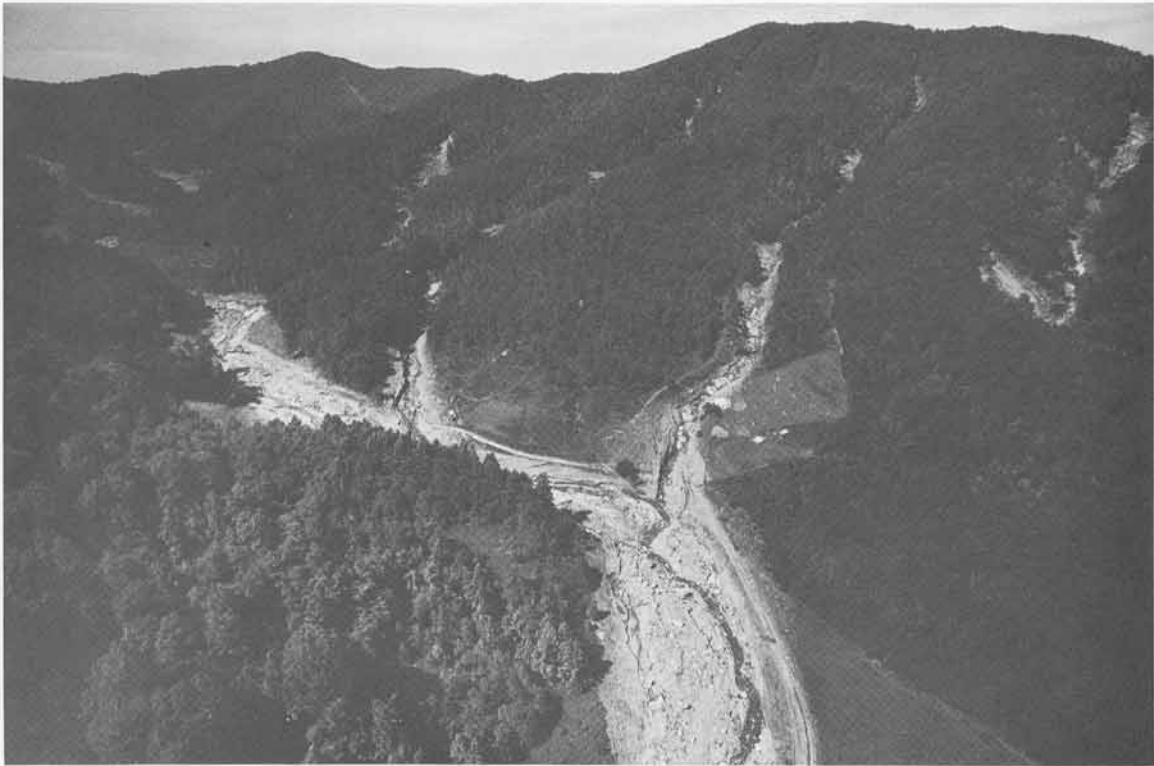
8 Erosion of soil to bedrock in denuded ravines and subsequent discharge of rubble to stream below; note large boulders adjacent to and in stream bed (foreground). North Prong of Davis Creek, about 4.5 miles south-southwest of Woods Mill.

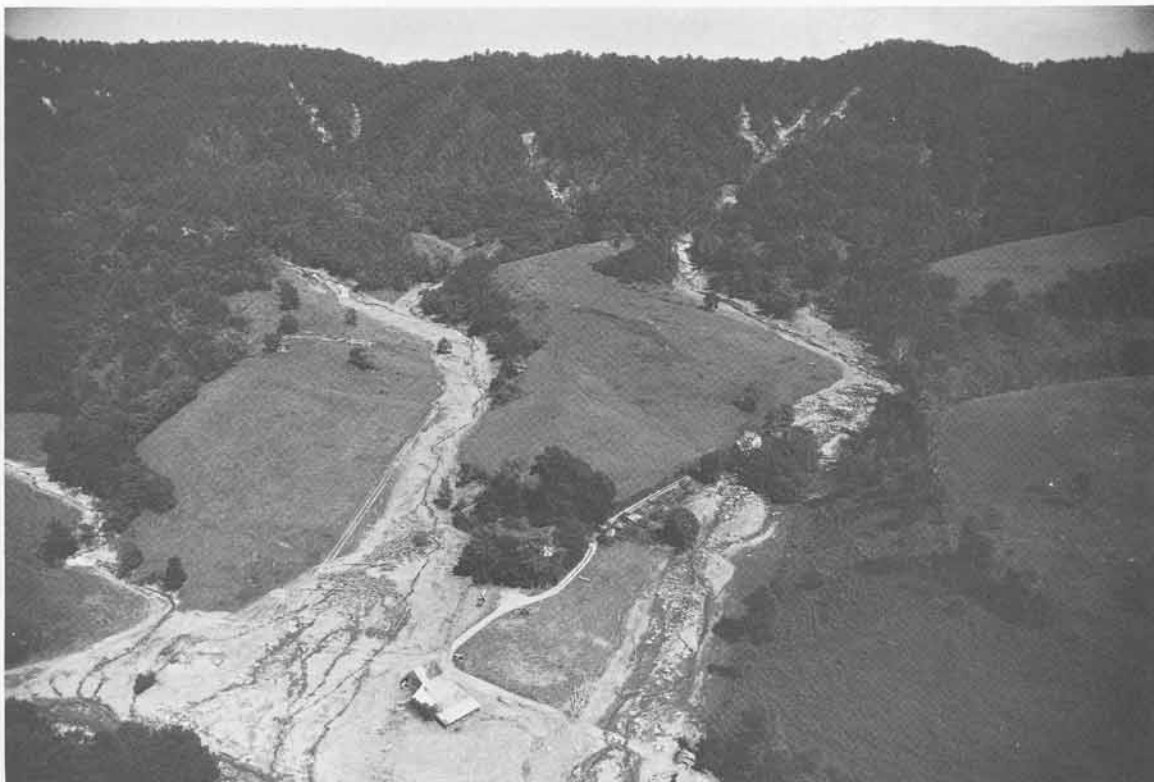
9 Chutes and incised stream channels; natural piling up of tree trunks and boulders occurred where the gradient of the slope was less steep. East Branch of Hat Creek, south of Shaeffer Hollow, about 2 miles northeast of Roseland.

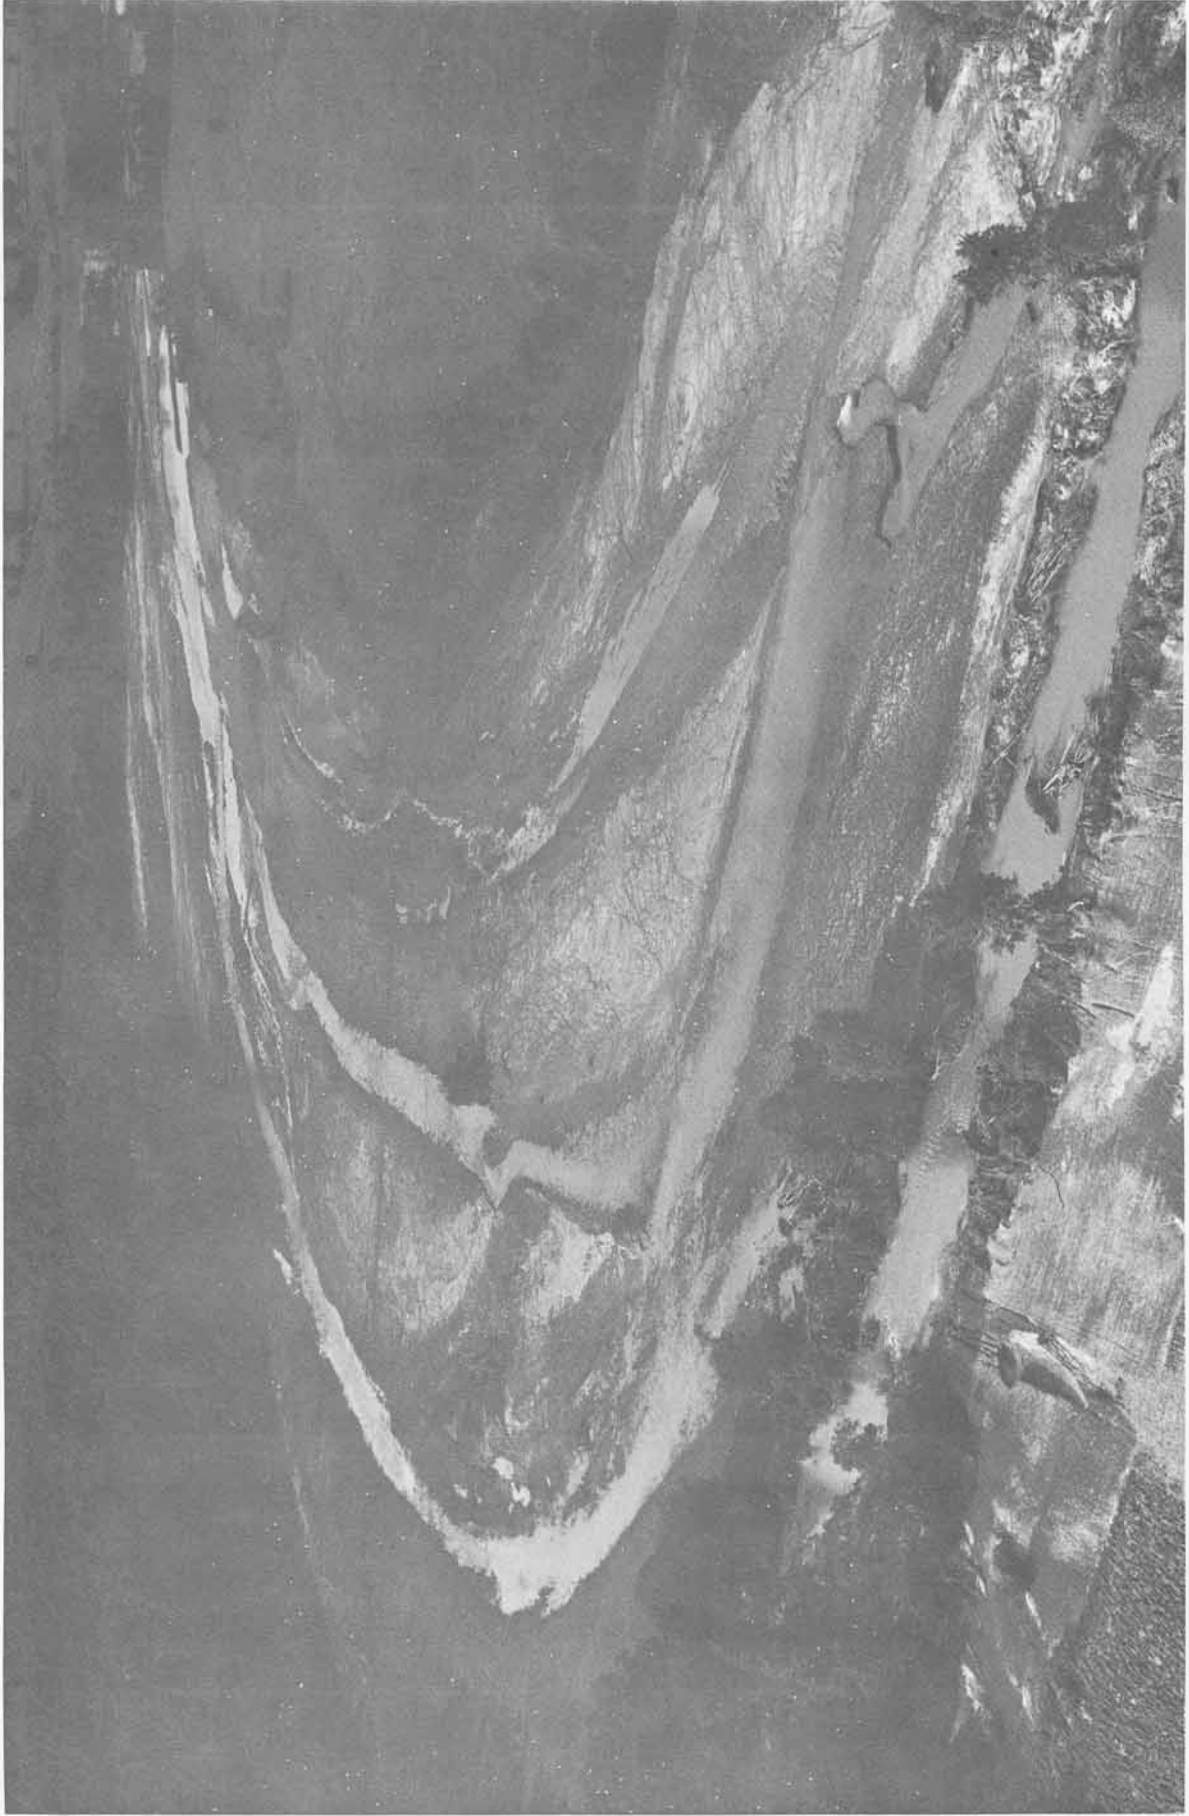
10 Channel development on slip-off slope of Tye River. Natural levees (foreground) are eroded by small rivulets, and a mud-flow has been discharged from a cone-shaped depression (lower left). About 1.5 miles due south of Roseland along Tye River.

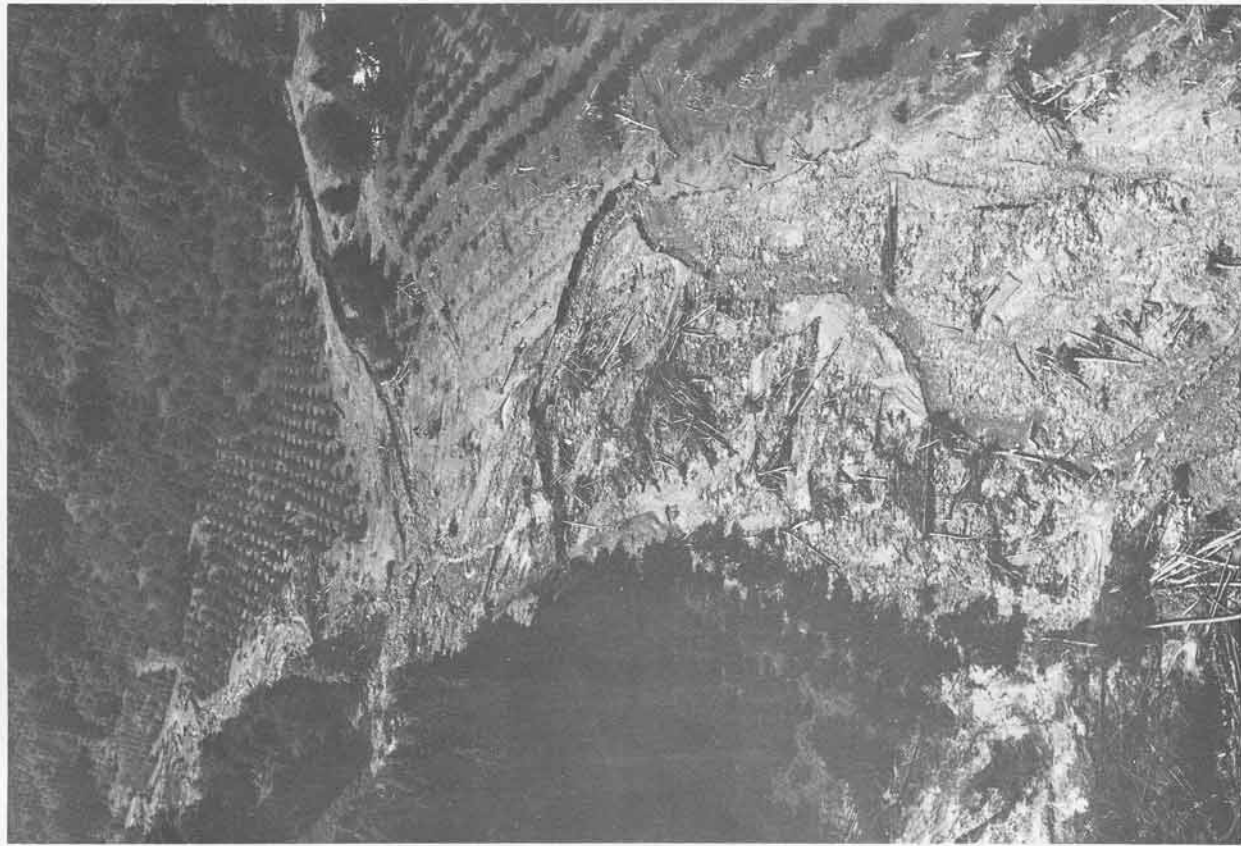
11 Newly incised channel on pre-existing alluvial material that is partially covered by chaotically deposited rubble from the headwaters of the North Prong of Davis Creek. About 4.5 miles southwest of Woods Mill.

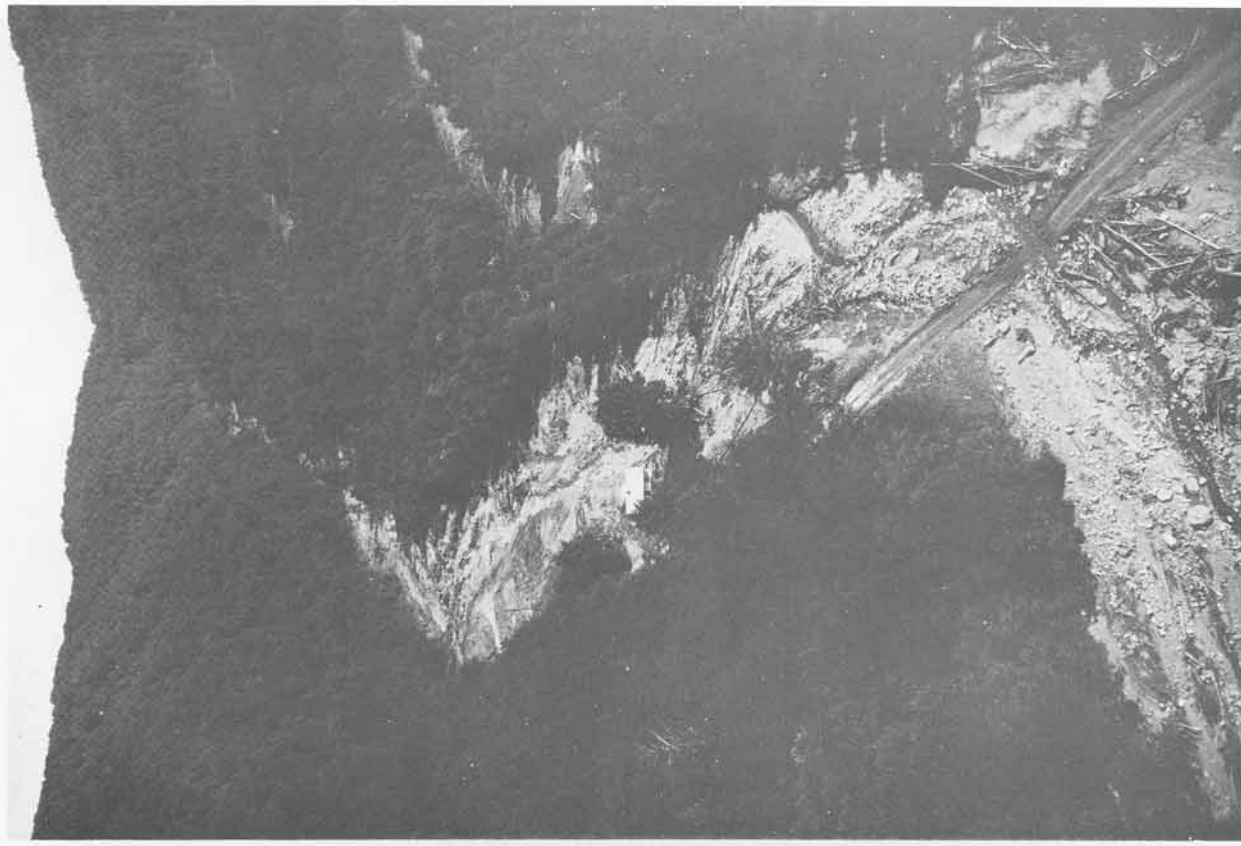
12 Jumble of boulders and tree trunks deposited during debris-avalanche. Edes Hollow, about 1.5 miles north-northeast of Lovings-ton.

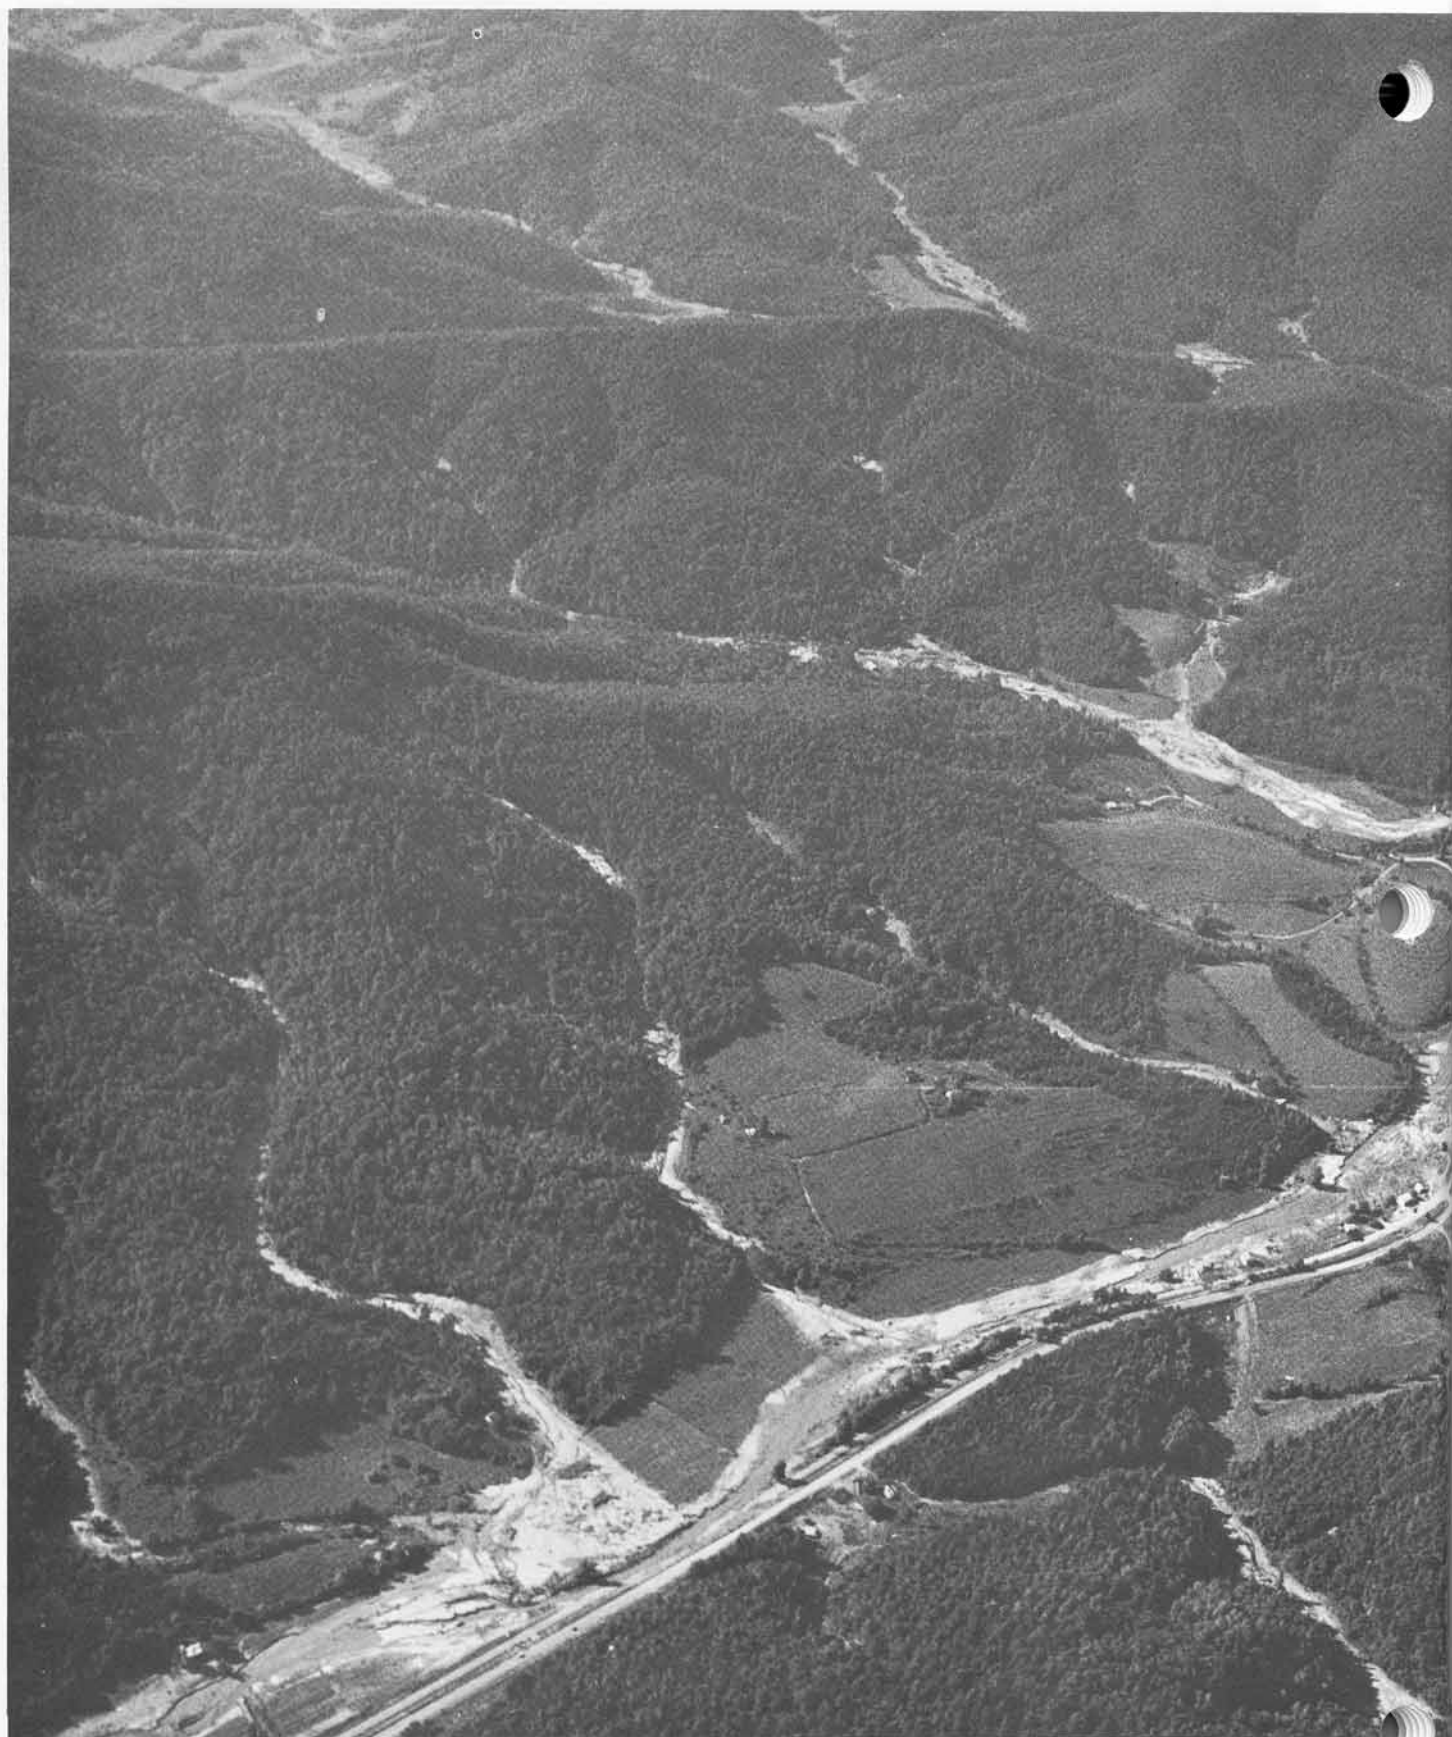
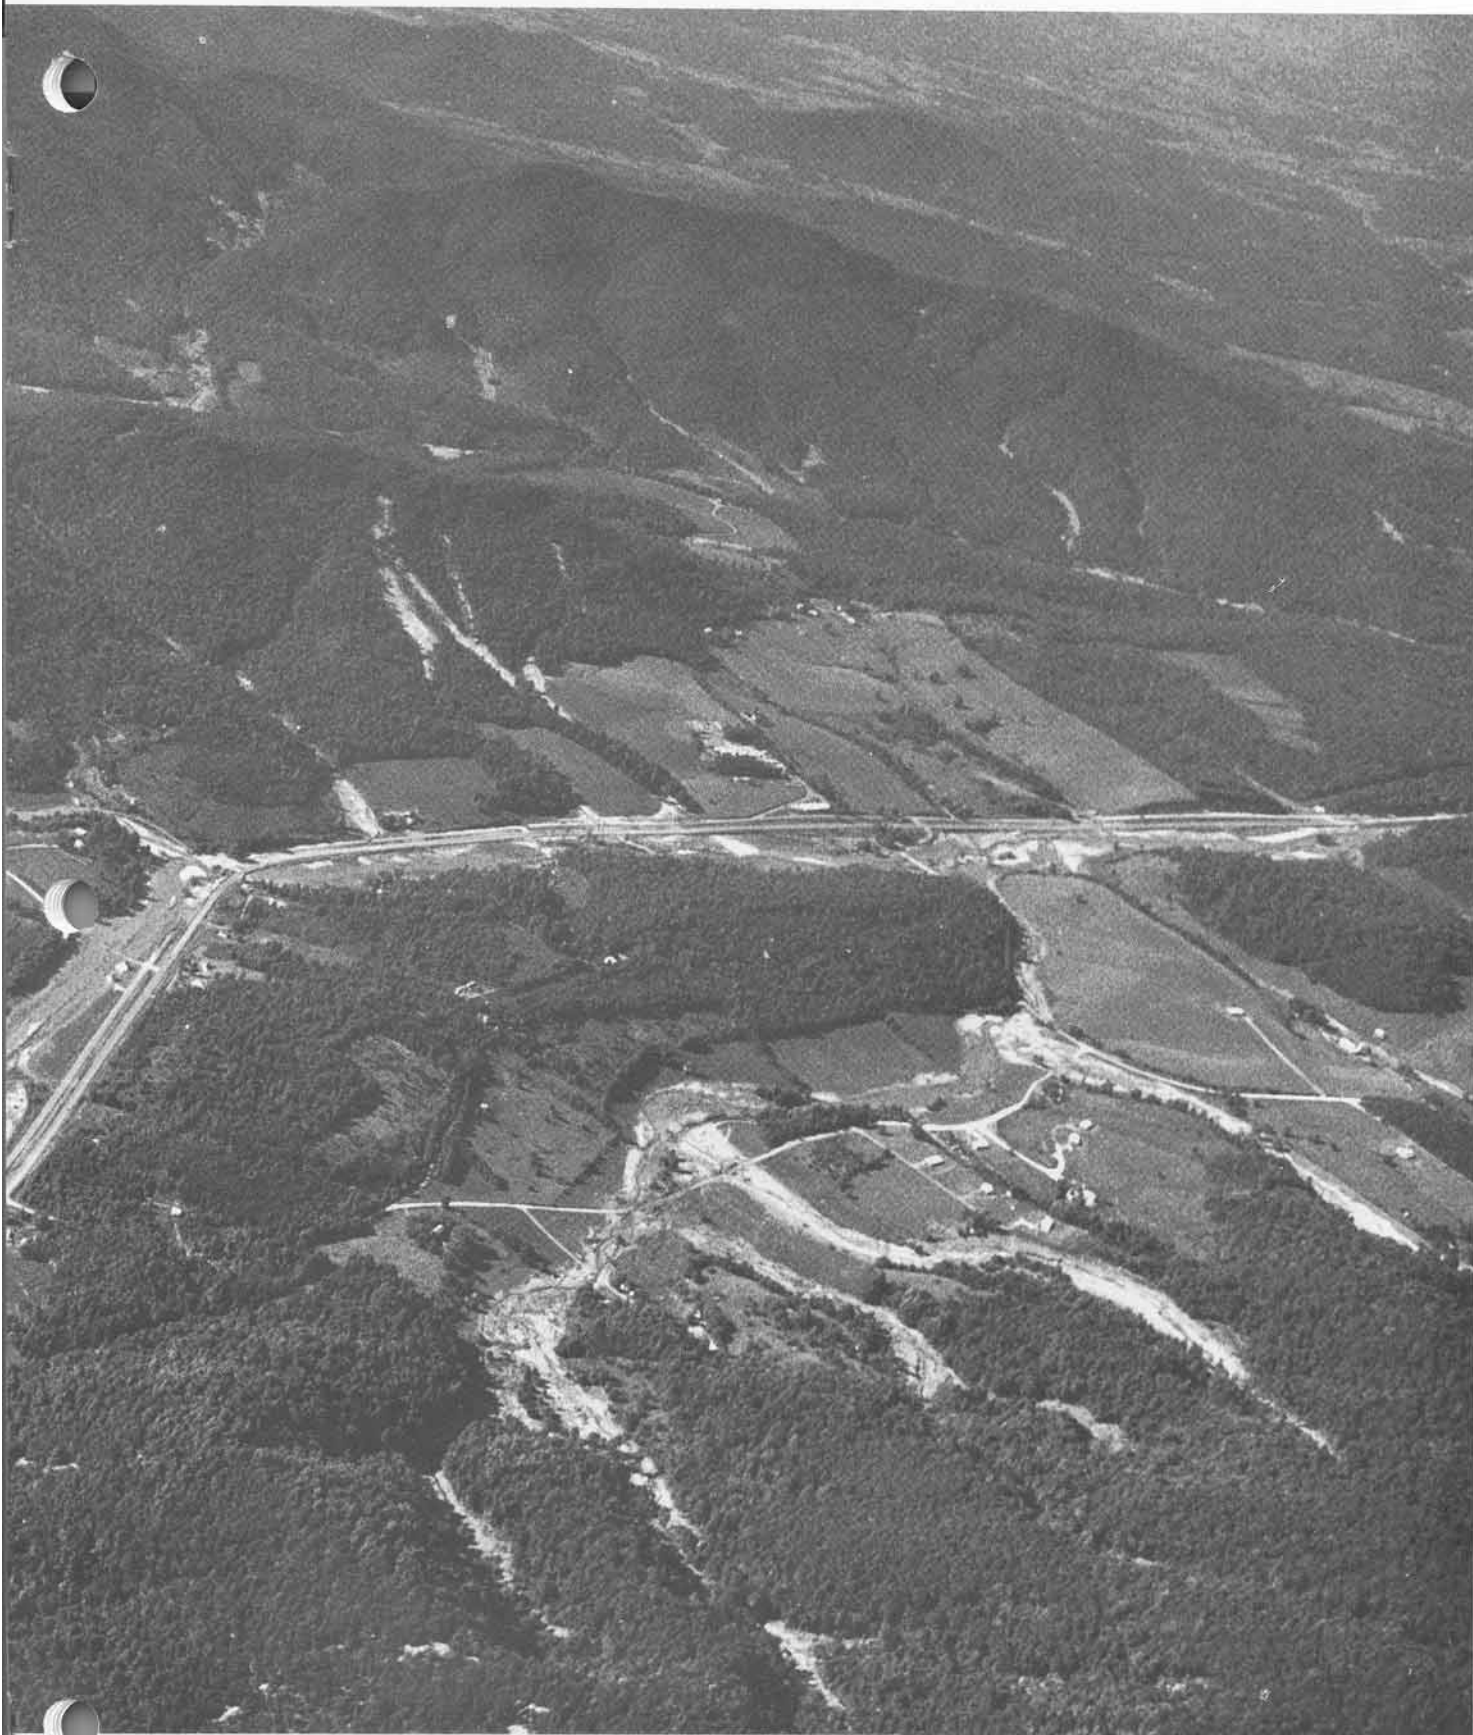
13 Catastrophic headward erosion of ravines with development of chutes and accumulation of rubble and debris (extreme left) and Roberts Mountain (upper right); a

and veneers in some valleys. Valleys of Muddy Creek (foreground) and Davis Creek (background); Woods Mountain and Myndus (center right) adjacent to U. S. Highway 29.

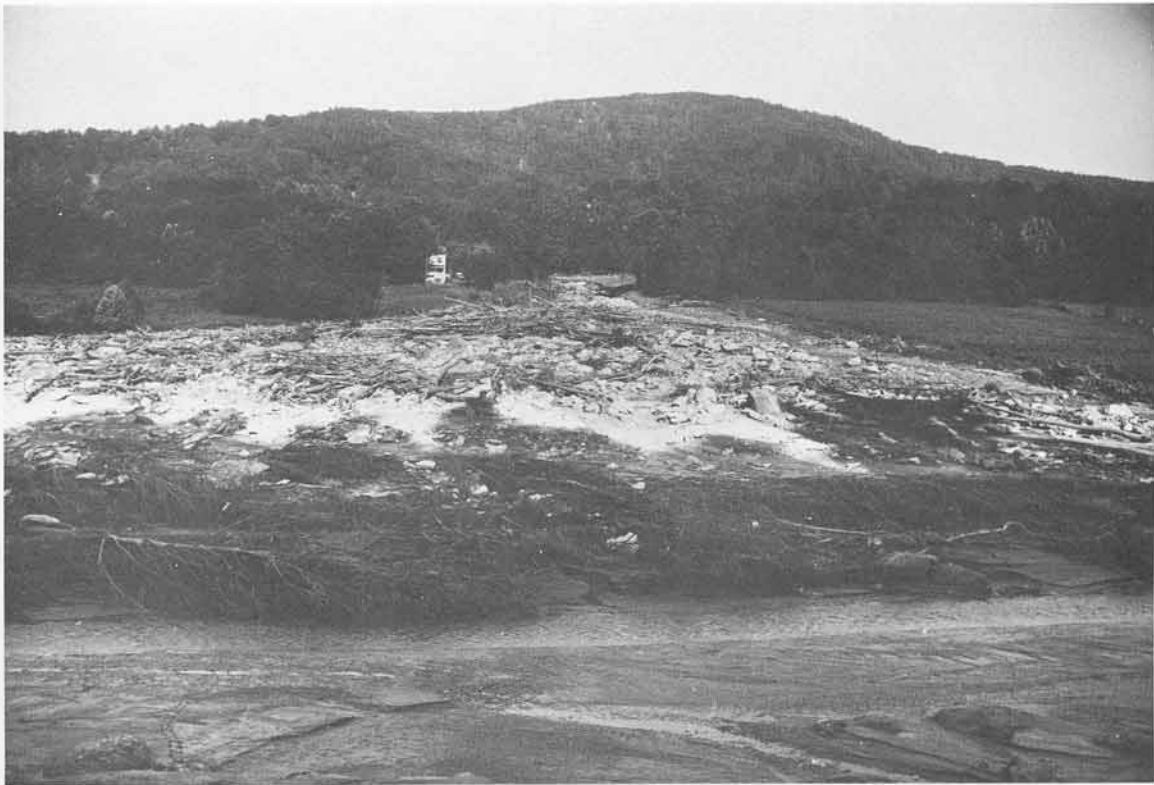
14 Debris cone containing boulders and tree trunks at base of east slope of Woods Mountain; Muddy Creek at toe of cone. About 5.8 miles north of Lovington.
